EVALUATION OF THE PERFORMANCE OF POLYURETHANE FOAMS IN RIGID PAVEMENT PRESERVATION

A Thesis Submitted to the Faculty of the University of
Tennessee at Chattanooga in Partial
Fulfillment of the Requirements of the Degree
of Master of Engineering

The University of Tennessee at Chattanooga
Chattanooga, Tennessee

August 2018

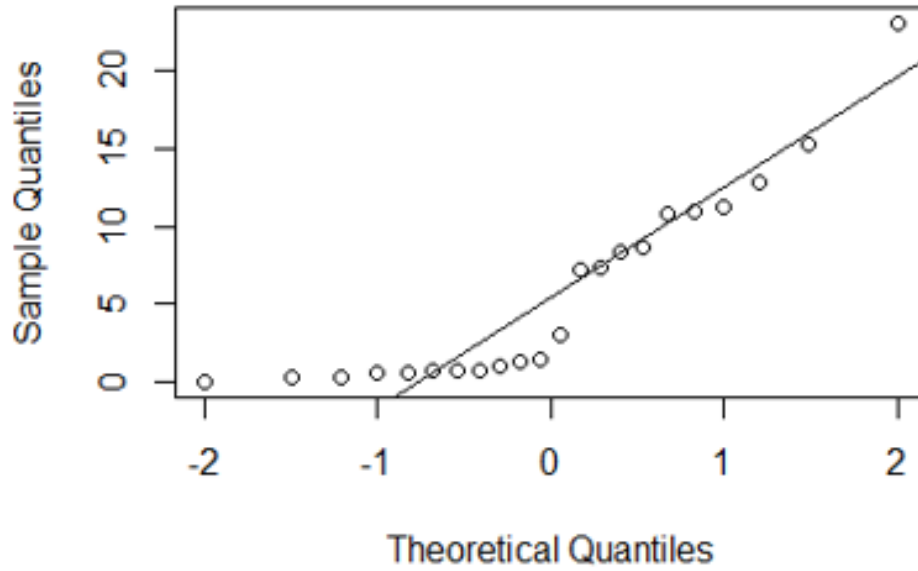
Figure C36 Right wheel track_Nineteen months after application of HDP foams
